Automotive Water Pump Leaks – Temporary vs. Active

Installer & Technician Reference: Water Pump Leak

Water Pump Leak Inspection and Diagnostic Tips

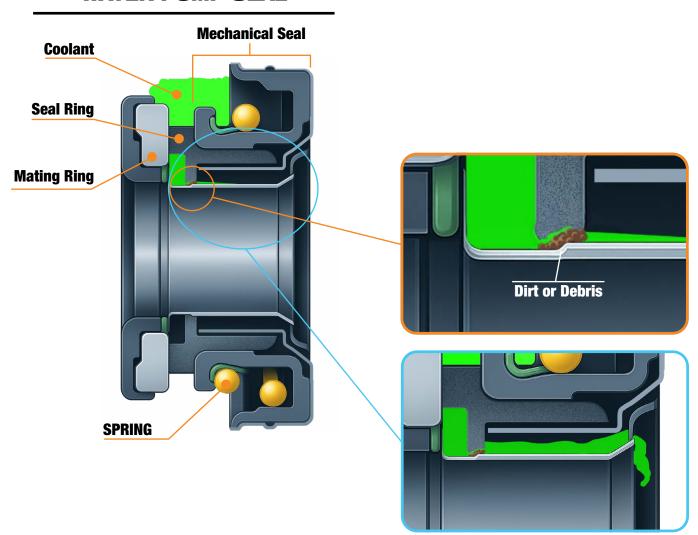
WATER PUMP SEAL

If debris gets caught between the mating ring and the seal ring, it can create a small gap. This gap lets coolant slip past the mechanical seal, collect in the fluid catch pocket, and exit through the weep hole. This type of leak is only temporary and will usually stop once the debris breaks down or works its way out of the seal.
